HPP LENGARICA / ALBANIA

Ecological Flow Monitoring

Date of Report:
08/2025

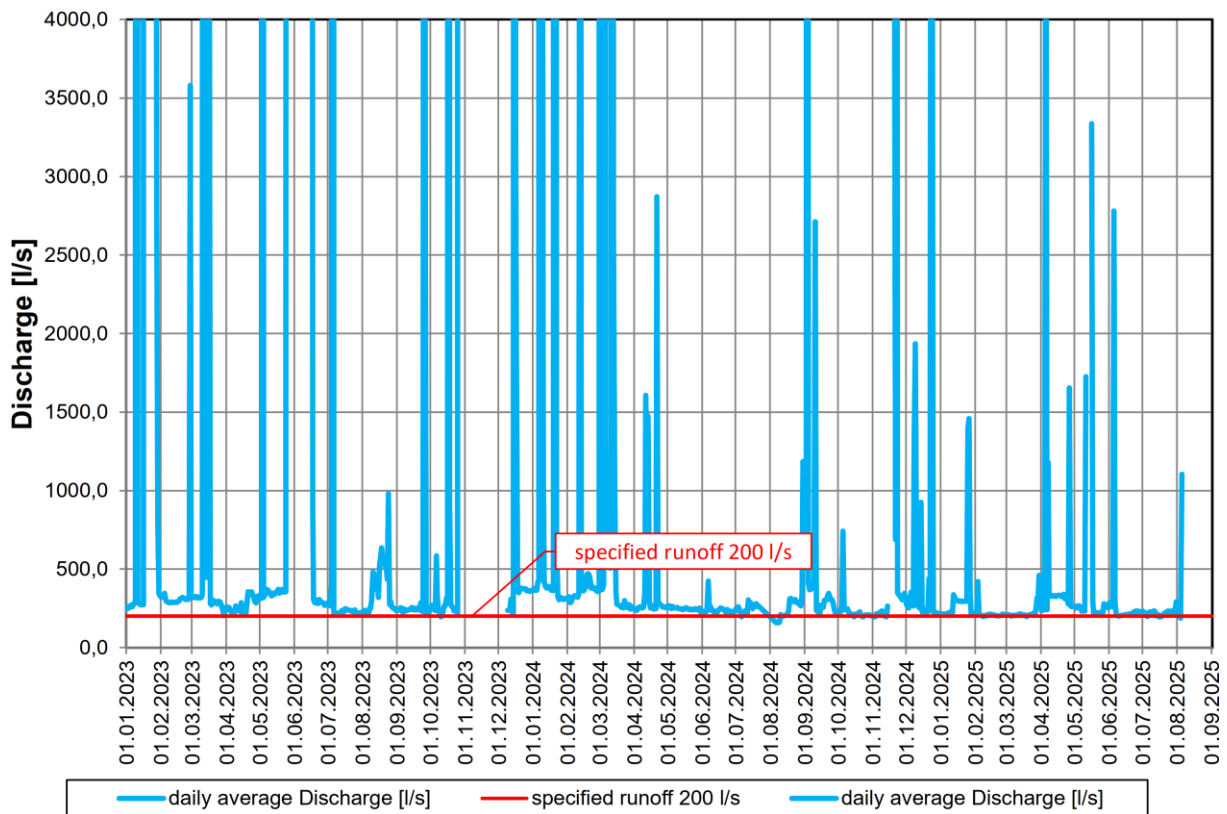
Diagram: Discharge at the intake
